SAFETY INVESTIGATION REPORT

REPORT NO.: 21/2021

MV X-PRESS GODAVARI **Fire in a container** **while anchored** **at Sandheads Anchorage, India** **28 September 2020**

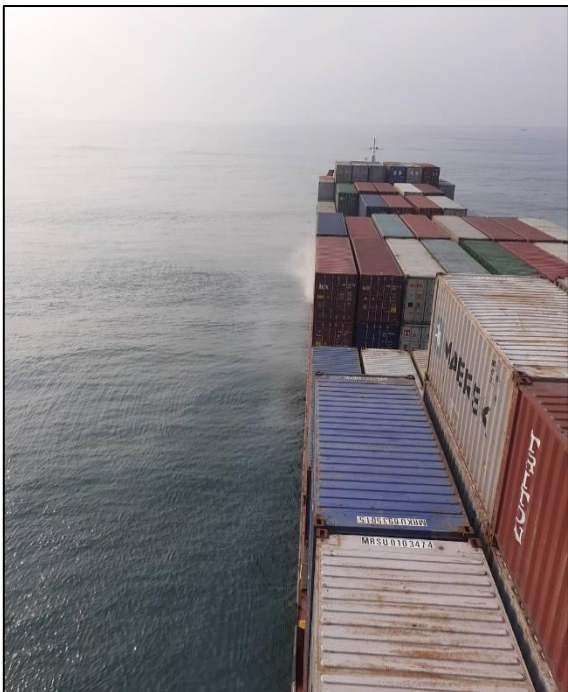
In the morning of 28 September 2020, during his 0400 to 0800 anchor watch, the chief officer noticed a container on deck emitting smoke (Figure 2). The master, who was also on the bridge at that time, noticed the smoke as well, and instructed the chief officer to investigate further.

Figure 2: Visible smoke coming over the vessel's port side

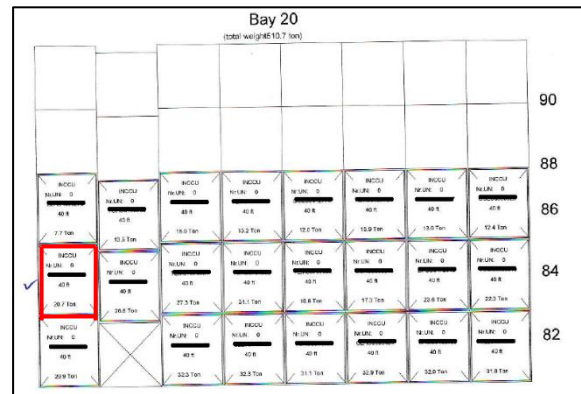
At around 0730, as soon as the chief officer reached Bay 20, he noticed smoke bellowing from a container in position Bay 20, Row 08, Tier 84 (200884) (Figure 3). He immediately reported this to the bridge and proceeded to the muster station. The master raised the general alarm at once and all crew proceeded as per vessel's fire contingency plan.

Figure 3: Deck Bay 20 plan. Container emitting smoke, marked in red

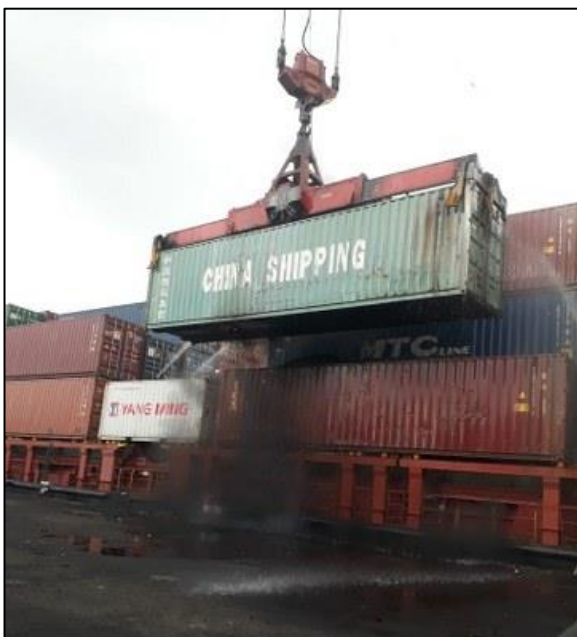
Figure 4: Unloading of the container

During unloading operation, a section of the bottom of the container was displaced, and part of the burning cargo fell on the roof of the container below. This was immediately tackled by the crew on board, while a shore fire-fighting brigade used foam extinguishing media to extinguish the fire within the container.

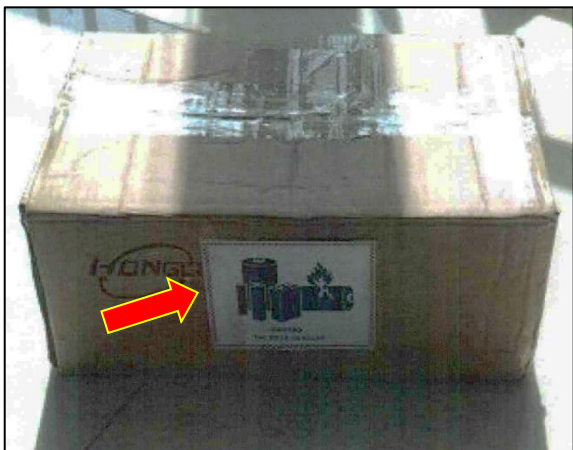
Figure 5: One sample package marked with the lithium battery mark

Although the packages inside the container was affixed with the lithium battery mark, the crew had no information on the cargo²¹.
