MARINE SAFETY INVESTIGATION REPORT

**Safety investigation into the failure of a lifeboat wire rope fall
on board the Maltese registered passenger ship**

CELEBRITY CENTURY

MARINE SAFETY INVESTIGATION REPORT NO. 08/2014

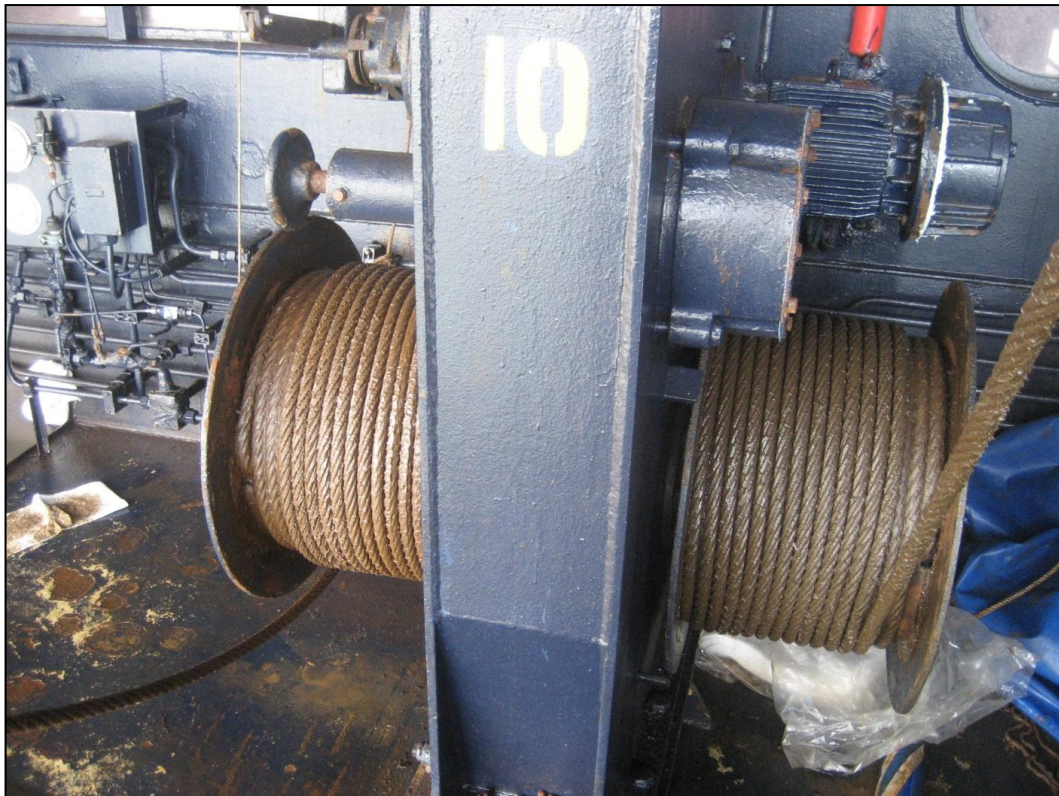
Figure 2: Wire rope on the winch drums for tender boat no. 10.

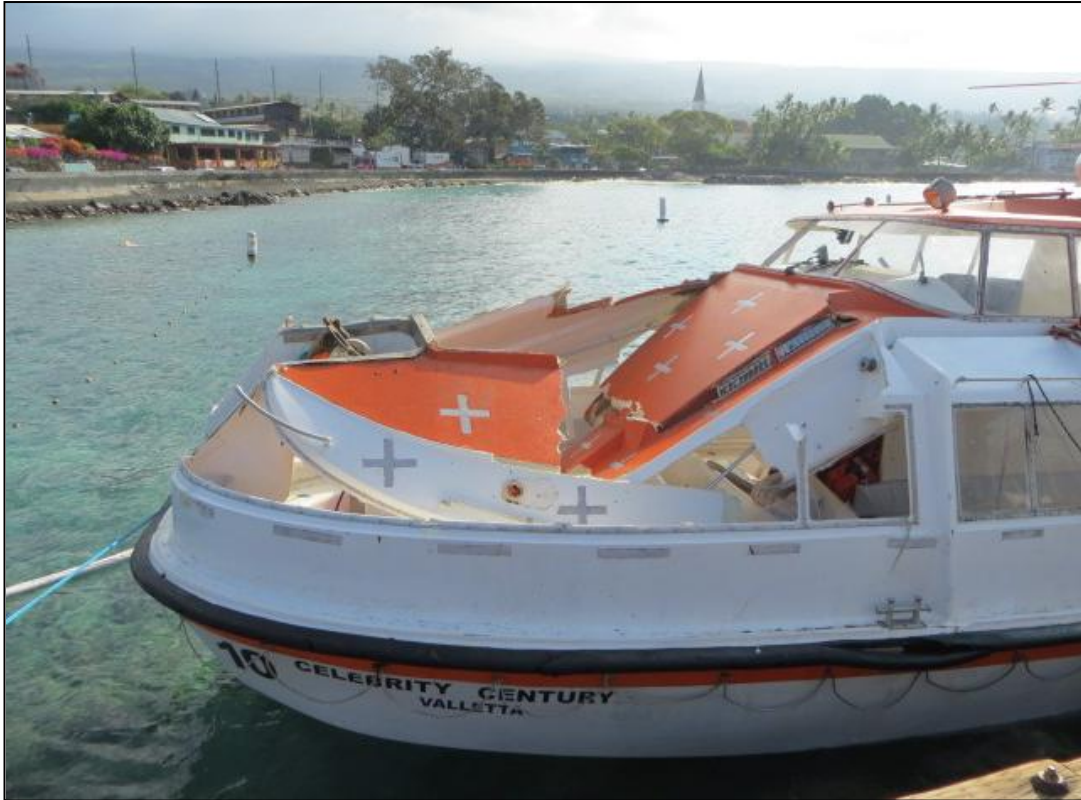
The wire rope failure and subsequent drop caused extensive damage to the tender boat’s hull and upper structure (Figures 3A and 3B).

Figure 3A: Tender boat no. 10 - damage to upper structure

The damaged tender boat was sent for repair in Hawaii by the OEM. It was agreed that it would be required to undergo a load test of 200% of the fully loaded tender boat prior to its return to service. The davits of tender boat no. 10 was also to undergo a dynamic load test.

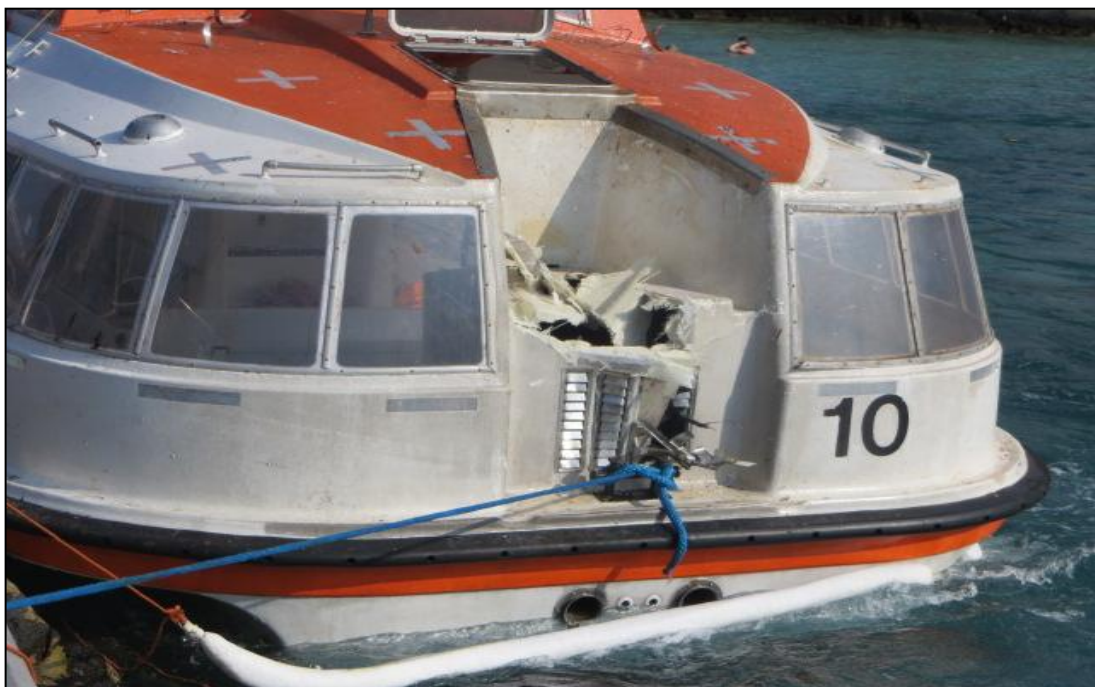
Figure 3B: Tender boat no. 10 - damage to the stern area from where the aft boat hook ripped out

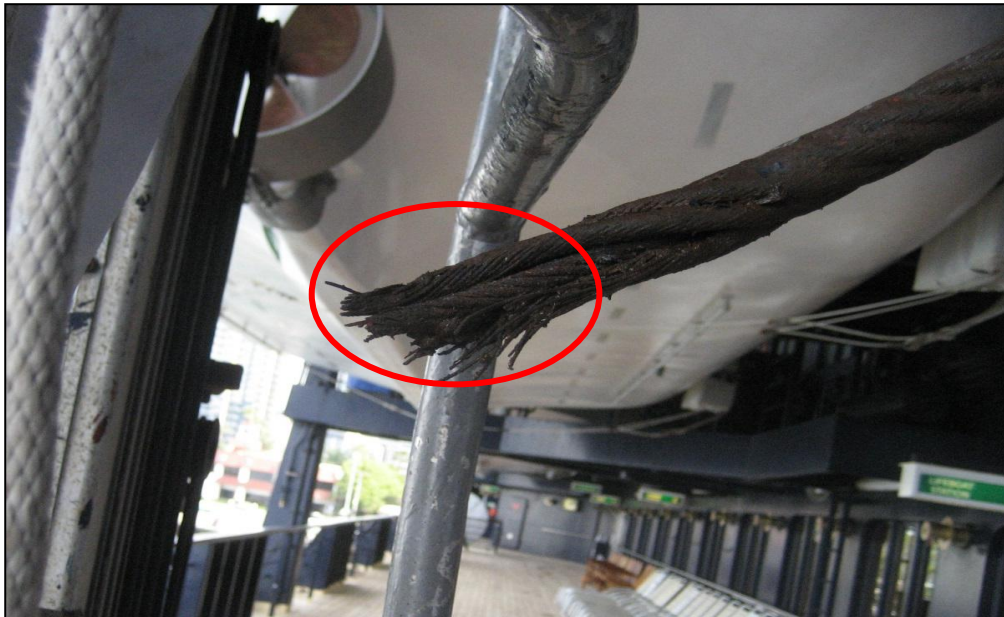
The MSIU representatives arrived on board *Celebrity Century* on 04 March 2013 in San Diego, California, USA and an inspection of the wire rope was carried out at the point where it parted. The wire rope had been left in position after the accident and as such was left exposed to weather conditions on the passage from Hawaii to San Diego. Although it appeared as if there was slight corrosion in the broken strands, it

was difficult to analyse it due to the amount of grease on the wire rope (Figure 4). There were also a few ‘fish hooks’ noted on the wire rope in the area around the part.

Figure 4: The parted wire rope

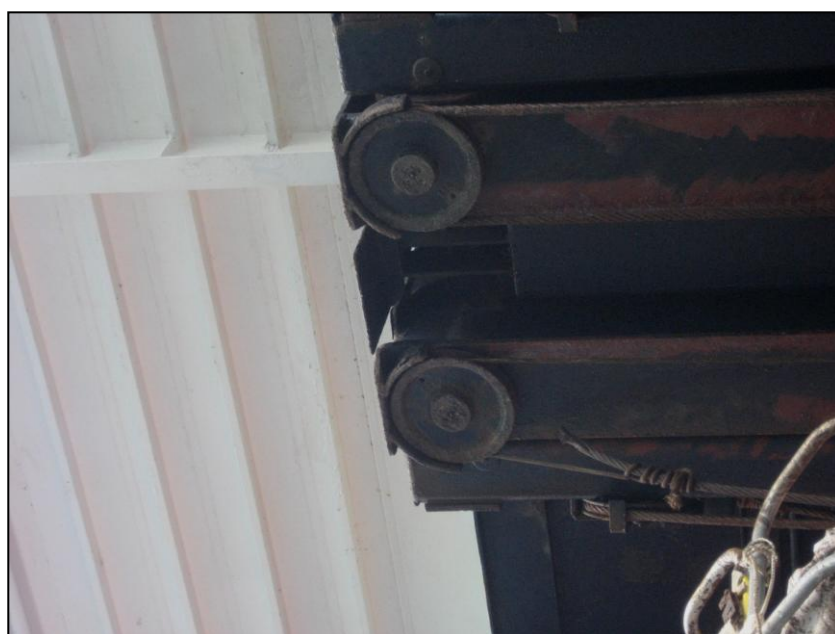
Efforts by the crew members were undertaken to ascertain exactly where the area that parted was located at the time of the accident but it was difficult to do so. An approximation was made as to where the parted wire rope section was in both the stowed position and an extended position of the telescopic trolley arms. The approximation had the area of the wire rope that parted around a sheave in both of the two positions, *i.e.* two different sheaves (Figure 5).

Figure 5: Parted wire rope at its approximate location prior to the accident

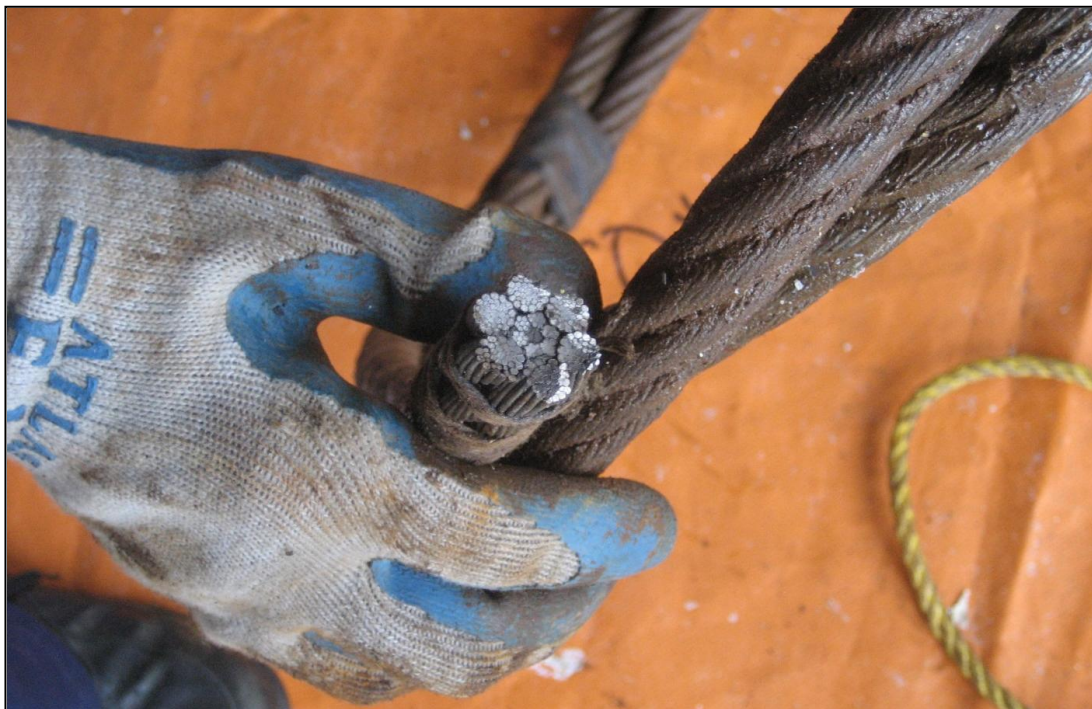
Two sections of the failed steel wire rope from tender boat no. 10, each approximately 3.6 m long, containing mating fractured ends, were submitted to Lucius Pitkin, Inc.¹² (LPI) for materials evaluation and failure analysis (Figure 6).

Figure 6: End of the wire rope cut for analysis

LPI concluded that failure of the wire rope was directly attributable to severe corrosion attack of the strand wires. The corrosion attack reduced the wire rope's cross-sections to such an extent that the wire rope could no longer withstand the applied stress, resulting in a single occurrence overstress fracture of the wire rope.

- the wire measured approximately 22 mm diameter, right lay regular lay arrangement, 6 x 36, IWRD, Warrington Seale¹⁵;
- the entire wire rope surface exhibited brown and light brown corrosion product deposits;

- dried grease was evident with the corrosion product;
- the outer surface of the wire rope and the wire material were free of any pre-existing defects;

- wire fracture ends were severely corroded;
- wire crowns exhibited severe corrosion attack representing as much as 50% reduction of cross-section;
- initial zinc coating had depleted during service;

- tensile test results on a portion of the wire rope, remote from the fracture, showed the breaking strength of the wire rope had been decreased by at least 25% of the rated load; the reduction in strength at the location of the fracture was likely to be greater than 25%; and

- the presence of chlorine indicated that sea water, which sprays on wire ropes during service, accelerated the corrosion of the wire rope.

The wire rope failure was attributable to severe corrosion at the failure site. The severe corrosion of the wire rope was attributed to lack of adequate protection from exposure to the marine environment. In this case, the wire rope protection was expected to be provided by frequent application of anti-corrosive grease.
