SAFETY INFORMATION AND ADVISORY NOTICE (SIAN)

Transport Malta Civil Aviation Directorate Safety and Compliance Unit Transport Malta Centre Triq Pantar Lija LJA 2021 Malta aviationsafety.tm@transport.gov.mt
SIAN Number: 01/26	Issue Date: 16/06/2026	
Subject: Safety Awareness of Overwing Emergency Exit Hatches During Aircraft Maintenance

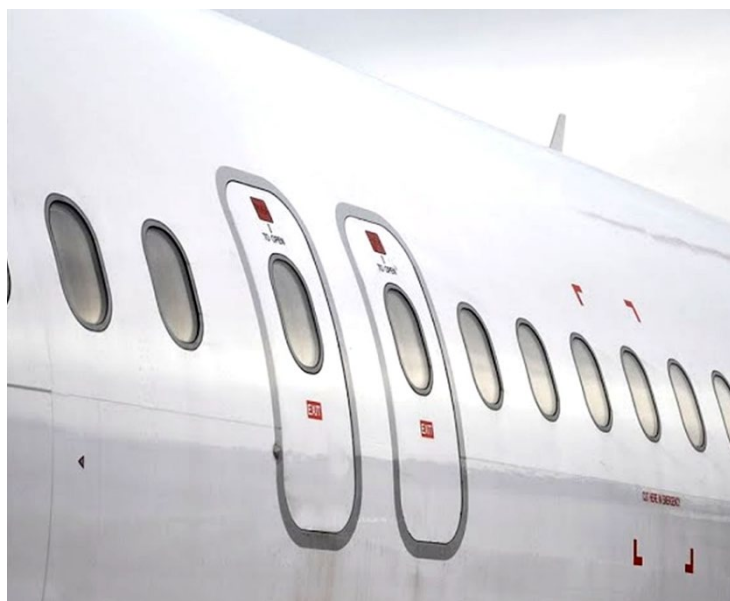
- 3.1 Overwing emergency exit hatches can be particularly susceptible to inadvertent activation if the system is not deactivated. Emergency exit hatches can be operated from the outside, and if the latch mechanism is in the armed position, this may result in unintended escape slide deployment.
- 3.2 Type III emergency exits are operated from inside the cabin by removing a protective cover and pulling the release handle. These exits can also be accessed externally from the wing surface, where activation is achieved by pressing a red push panel. The simplicity of this design means that even personnel without specific training can unintentionally open the exit when force is applied to the panel.

Figure 1 - Type III Overwing hatches (Airbus A320 aircraft)

- 3.6 To mitigate the risk of recurrence, the following actions are recommended:
 - Introduce a formal door safety control procedure during painting and similar maintenance activities.

- Ensure escape slides systems on all doors are disengaged/deactivated prior to work.

- Implement pre-work and post-work door status verification.
- Establish formal coordination between all stakeholders involved, particularly where:
 - A Part-145 maintenance organisation is responsible for the aircraft, and
 - Third-party contractors (e.g. painting teams) are performing work.
 - This coordination should include clear responsibilities, communication of door status, and formal handover/takeover procedures to ensure all parties are aware of the configuration and associated risks.
- Include this occurrence as a case study in SMS and Human Factors (HF) recurrent training for relevant personnel.
- Reinforce awareness of the risks associated with working near emergency exits, particularly when slides are armed
