SAFETY INVESTIGATION REPORT

REPORT NO.: 21/2021

MV X-PRESS GODAVARI **Fire in a container** **while anchored** **at Sandheads Anchorage, India** **28 September 2020**

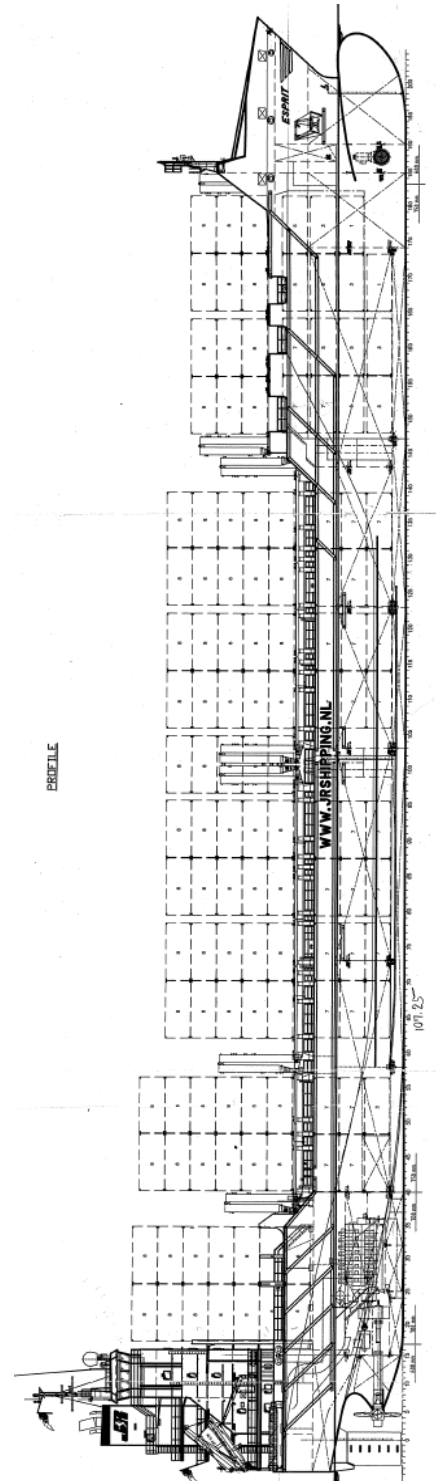
Figure 1: Extract from the vessel's GA plan

X-Press Godavari (Figure 1) was a container vessel of 8,971 gt and 917 TEUs¹, owned by BS Marine Private Limited and operated by Sea Consortium Pte. Ltd., Singapore. The vessel was built at Volharding Shipyard BV, Hoogezand, the Netherlands, in 2008 and was classed with Korean Register of Shipping (KR). The vessel had a length overall of 154.85 m and a moulded breadth of 21.50 m. The vessel's summer draft was 6.98 m, corresponding to a summer deadweight of 10,617 metric tonnes.
