MARINE SAFETY INVESTIGATION REPORT

**Safety investigation into the failure of a lifeboat wire rope fall
on board the Maltese registered passenger ship**

CELEBRITY CENTURY

MARINE SAFETY INVESTIGATION REPORT NO. 08/2014

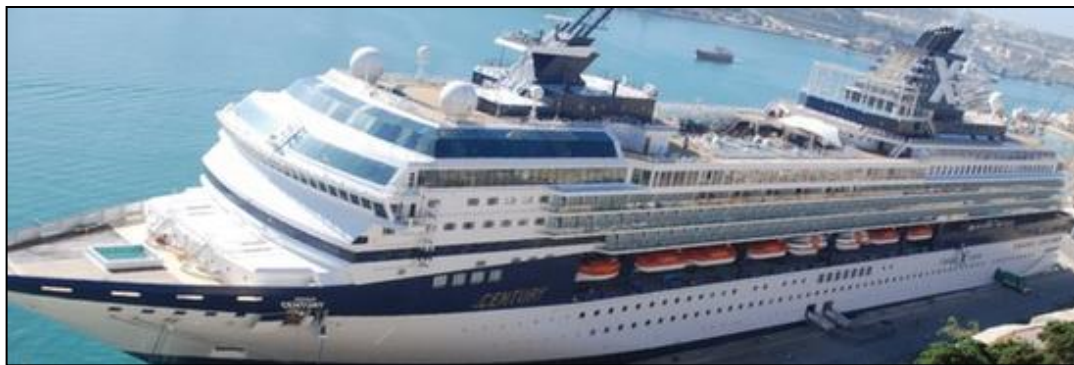
Tender boat no. 10 is located on the port side on deck no. 6, approximately 15 m above the water (Figure 1). According to the vessel's staff captain, tender boat no. 10 is used on an average of six to seven times (down and up) per month.

Figure 1: *Celebrity Century*'s port side, showing the location of the lifeboats and tender boats on Deck no. 6
